**6th International Conference on
Case Histories in Geotechnical Engineering, Arlington, VA, August 11-16, 2008**

**PROJECTS OF WASHINGTON, DISTRICT OF COLUMBIA, MARYLAND AND
VIRGINIA
FORENSIC GEOTECHNICAL ENGINEERING
HEALTH MONITORING AND RETROFIT OF INFRASTRUCTURE**

General Report – Session 8

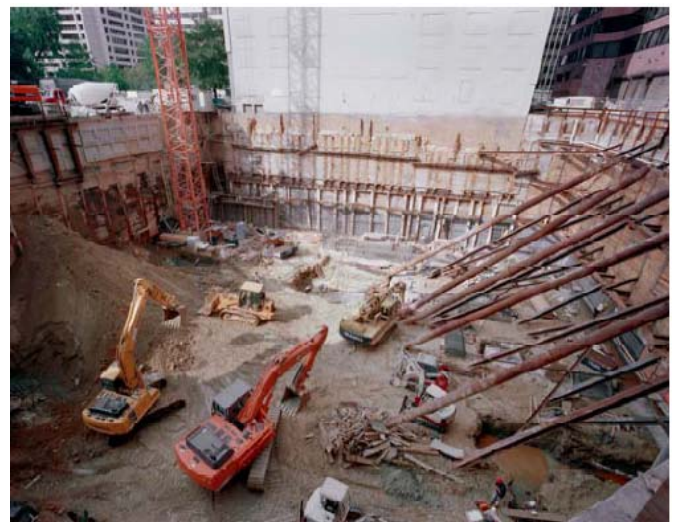
Fig. 13, Paper 8.01.a: Site excavation completed looking west at supported wall (©D. Cunningham).

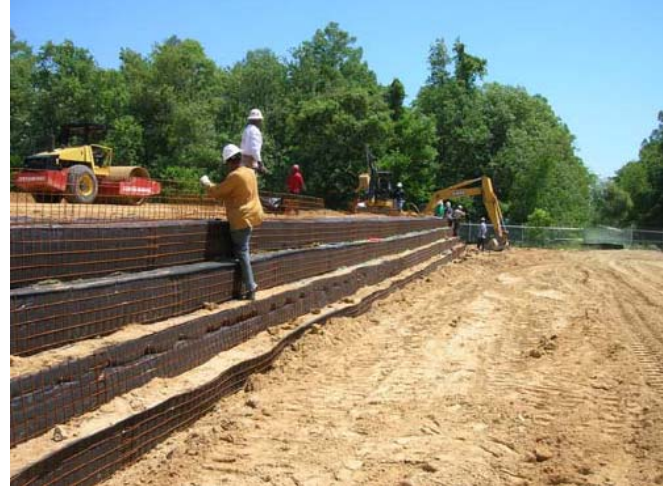
Fig. 7, Paper 8.02.a: Wrapped face of acid digester steep surcharge slope under construction.

- Design of the MSE resulted in ratio of reinforcement embedment length to MSE slope height of 2.8, higher than what would be required for stable foundation soils (generally less than 1).

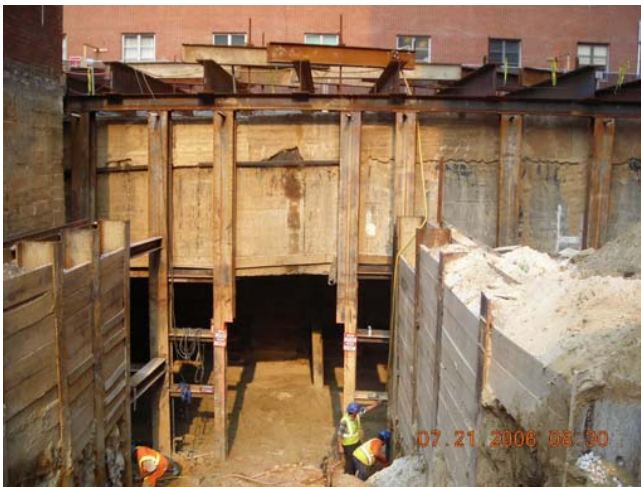
Photo 10, Paper 8.03.a: Completed support of excavation and shoring systems.

Monitoring strips and points were installed along the tops of each bracket pile and along the roof of the existing tunnel structure. Crack monitors were installed at an existing expansion joint located directly in the center of the supported tunnel system. At the overall completion of the project, there were no signs of settlement within existing utility tunnel as well as notable movement of soldier and bracket piles. The unique shoring system conceived and utilized by Clark Foundations resulted in accelerated project schedule, minimization of the cost, and maintenance of the daily pedestrian traffic.

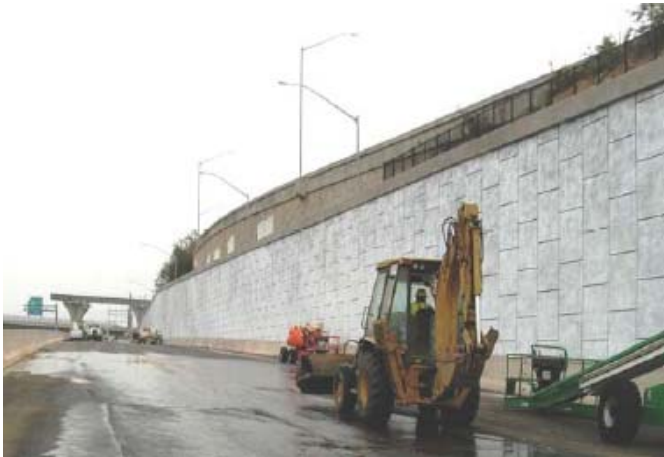
Fig. 11, Paper 8.04.a: Finished wall with MSE

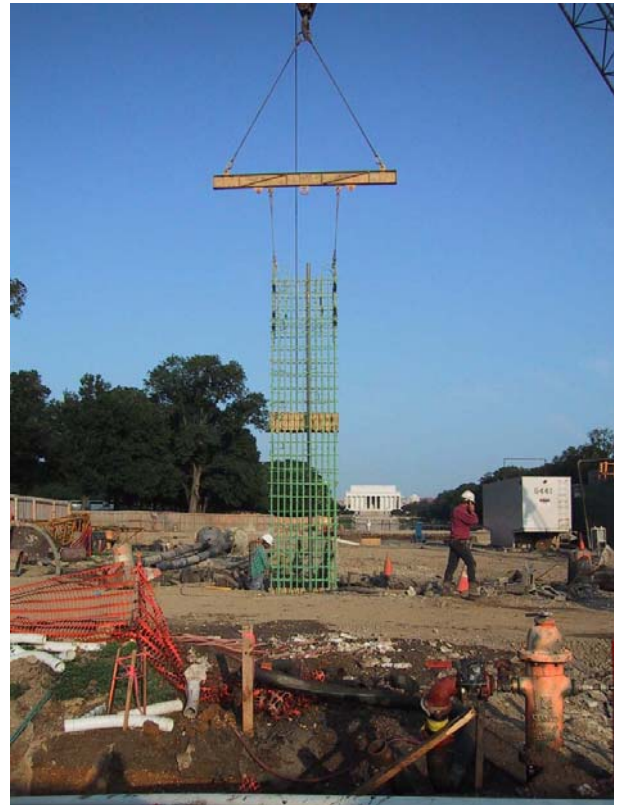
Fig. 10, Paper 8.05.a: Reinforcing cage being placed for WWII Memorial slurry wall (2002).

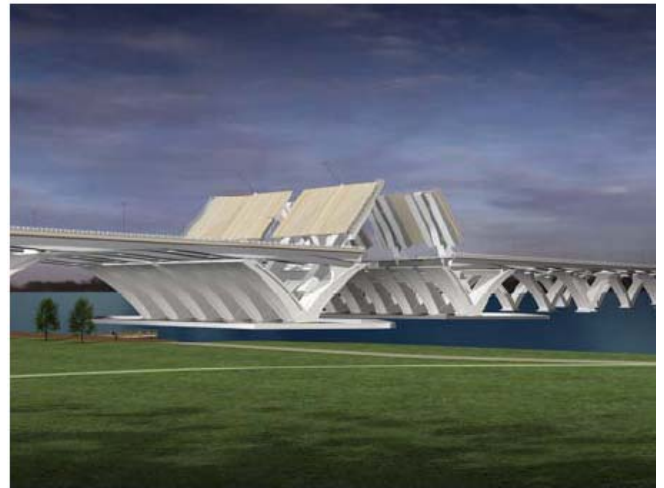
Fig. 2, Paper 8.07.a: Computer generated photographs of the new Woodrow Wilson Bridge.

This paper presents the design and performance of deep foundations used to support the new Woodrow Wilson Bridge (WWB). The types of deep foundations used for the project, performance criteria assumed during the design, measured performance and difficulties encountered during construction, and resulting remedial actions, i.e., changes to contract installation criteria and/or re-design due to the unanticipated field conditions are shown in detail.

The new bridge will replace the existing bridge over the Potomac River to connect Alexandria, Virginia to Prince Georges County, Maryland. It will extend approximately 1.1 miles across the river, with a 367- ft long bascule span in the main river channel where the water depth is about 36 ft. The bridge is primarily comprised of fixed spans in relatively shallow water and a bascule span over the navigation channel. The subsurface soil profile was quite variable along the bridge alignment. In Virginia there was fill over soft alluvial deposits, underlain by dense Terrace deposits, as well as remnant

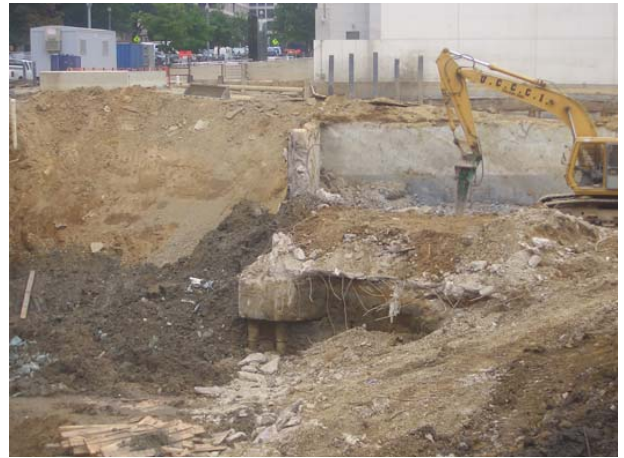
Fig. 2, Paper 8.09.a: Existing foundation system with Raymond Step Taper piles.

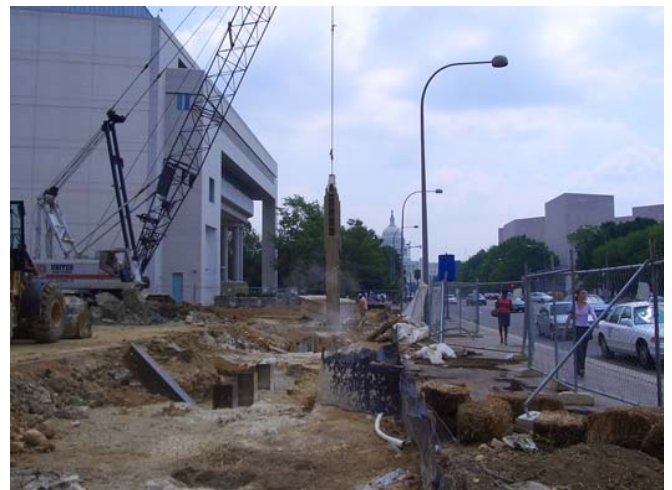
Fig. 5, Paper 8.09.a: Clamming operation for PSHG wall.

The PSHG wall was selected for 3 sides of the excavation and constructed by inserting pre-fabricated panels of steel H-piles and wood lagging into pre-excavated trenches using clamshell equipment normally used for slurry wall construction. A low strength self-hardening grout was used within the excavations to keep the sidewalls from caving, which hardened to strength of about 60 to 70 psi within few days after installation of panels. The PSHG wall resulted in a relatively impermeable cutoff wall.

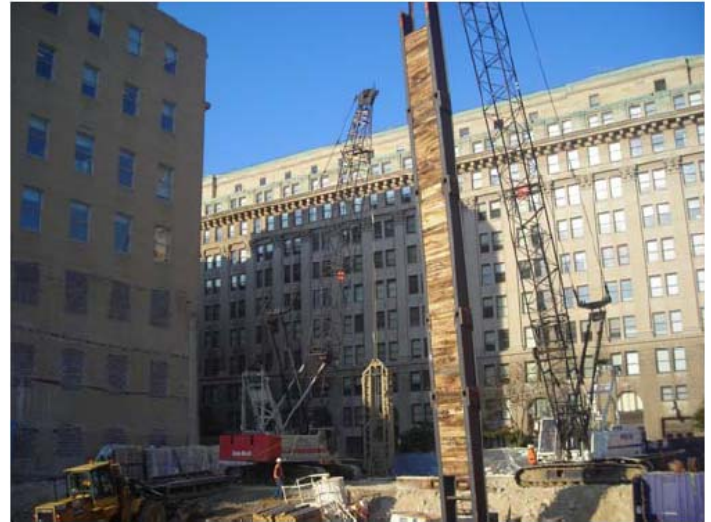
Fig. 5, Paper 8.10.a: PSHG wall clamming operation with service crane holding panel to be set.

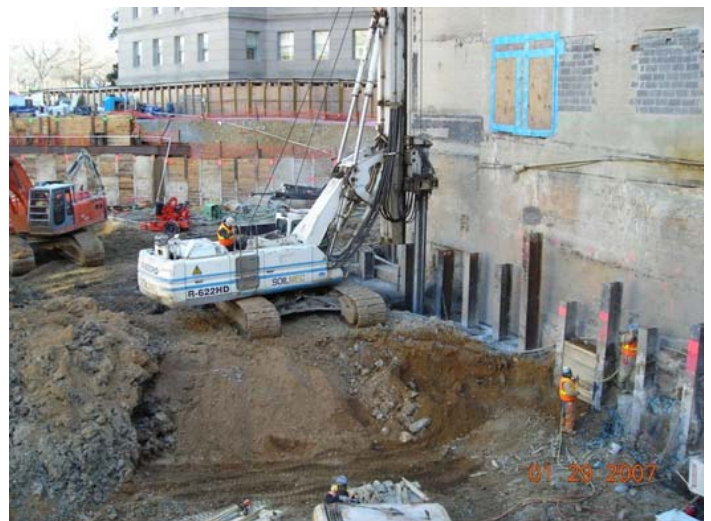
Fig. 9, Paper 8.10.a: Tangent wall drilling operation.

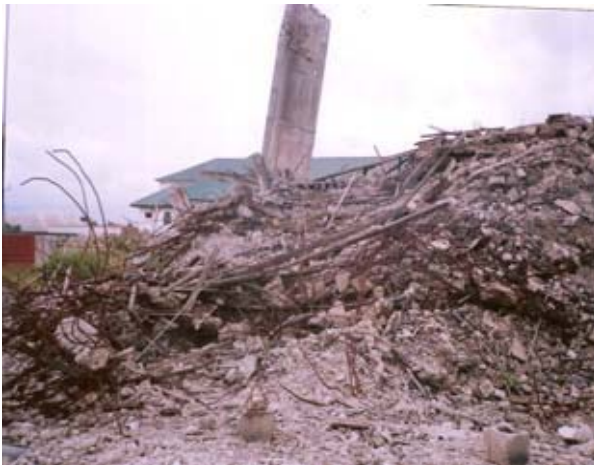
Fig. 6b, Paper 8.01.b: Remains of the collapsed building along the New Tombia Extension Road GRA III, Port Harcourt.

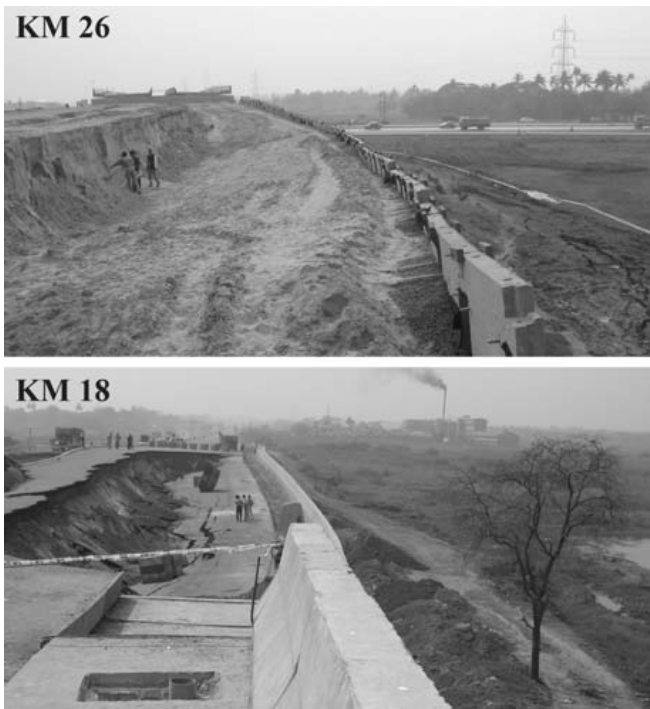
Fig.1, Paper 8.06.b: Failures at KM 26 and KM 18 site.

- Inadequate assessment of subsurface conditions led to global stability failure of the MSE walls used for two approaches of a highway bridge near Calcutta, India (Paper 8.05b).

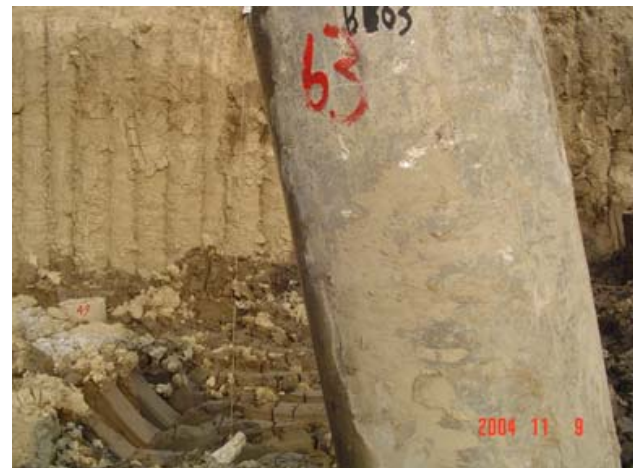
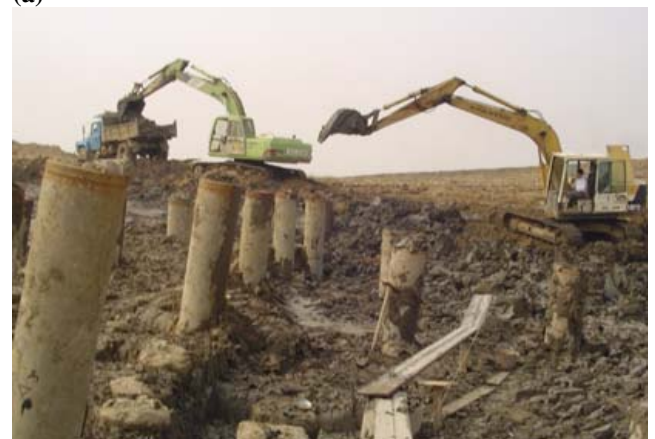
Fig. 2, Paper 8.13.b: Severe inclination observed during excavation a) construction; b) pipe pile inclination.

- A pipe pile foundation failed during construction of a pumping station in southern China mainly due to vibration disturbance of a thick soft layer of very loose sludge and high water content. While the pile tips were resting on a lower sand layer, the vibration made the sludge layer behave like a liquid, flowing gradually during the excavation, applying an unbalanced lateral force on the piles that lead to failure (Paper 8.13b).

lateral displacement at the top of the piles reached 2.6m. Forensic investigation immediately after the accident determined that the disturbance of the thick soft layer was the major cause of the pile failure. The soft layer consisted of a very loose sludge (low penetration resistance) with high water content. The tip of the piles was placed in a lower fine sand layer. Due to the vibration during the pile installation the sludge layer behave like a liquid, flowing gradually during the excavation, applying an unbalanced lateral force on the piles and offering insignificant amount of lateral resistance. The unbalanced lateral forces associated with the lack of lateral support of the piles caused large bedding moment action on the piles causing the failure of the splices. Pile integrity tests and inclinometer measurements were included in the forensic investigation. The paper analyses the pile breakage mechanism, estimating the drag forces generated by the flow of the soft sludge around the piles based on turbulence induced vibration. Based on the forensic study the authors provided recommendation for pile construction such as placing pad under construction to reduce vibration, field monitoring program, avoidance of steep slopes during construction.

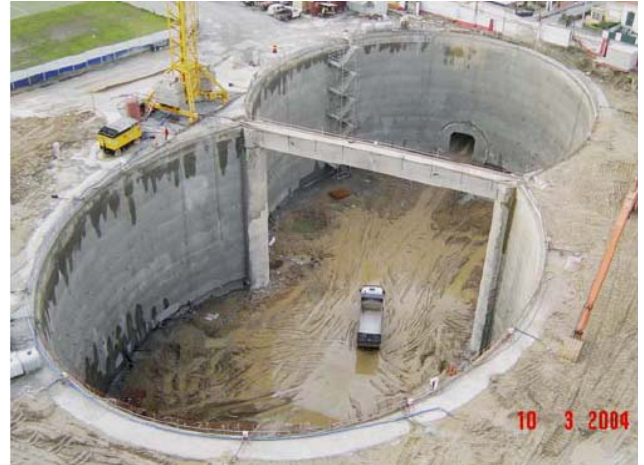
Fig. 5, Paper 8.04.c: Final excavation phase.

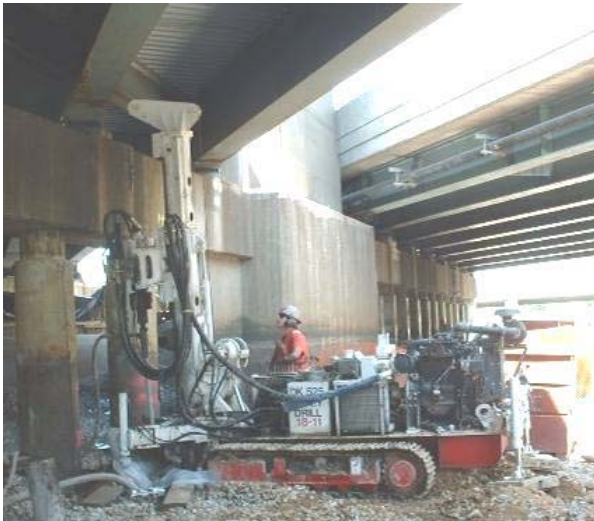
Fig. 3, Paper 8.05.c: Installation of production micropiles with limited headroom.

The paper presents the procedure for installation of the micropiles, including drilling methods under limited headroom and within temporary cofferdams, casing installation, insertion of the hollow core bar, and grouting procedures. Grouting mix design, grout pressures, drilling rates and grout testing were also provided. The paper included the quality control of the

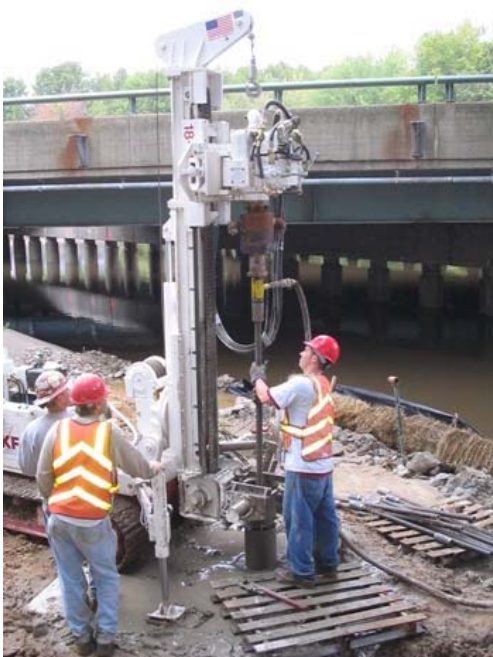
Fig. 4, Paper 8.05.c: Drilling hollow core bar test micropile.

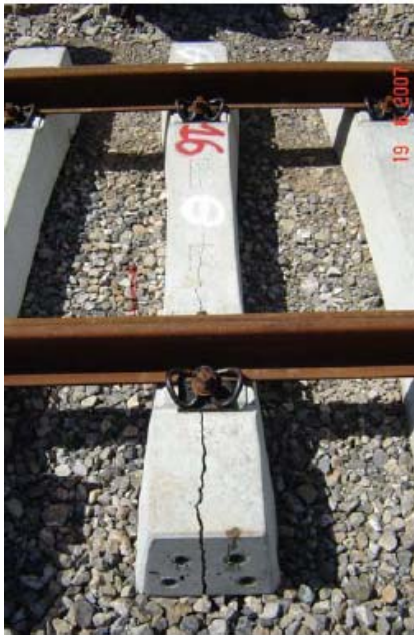
Fig. 6, Paper 8.13.c: Cracked sleepers.

The authors described and analyzed the longitudinal cracks observed in some of the pre-stressed monoblock sleepers of metric gauge during the rehabilitation of the Greek Railway Organization (OSE) line Korinth – Tripolis – Kalamata. The paper provided information on the methodology adopted by
